Seepage

Center Hill Dam was designed and built in the 1940's on a limestone foundation with joints, caves, and fractures. Small amounts of water move under and through the dam, seeking a path of least resistance. This movement is called seepage. All dams have some seepage; however, seepage must be controlled to keep the dam safe.

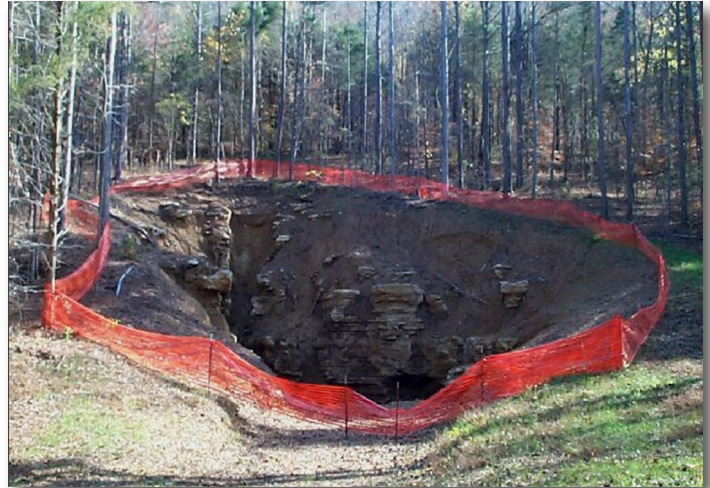
Following several years of high lake elevation, we first noted and began to monitor several sinkholes downstream of the left rim. This is the largest, about 25-feet in diameter when found in 1992. We dug into the sinkhole in 1999 to map and better understand how to close the opening from the lake to the sinkhole. The rock joints were filled with clay. We flagged and continued to monitor the area. In the spring of 2003, with a high lake elevation (over 672), the bottom clay began to sink and clay material was washed out of the picnic spring.

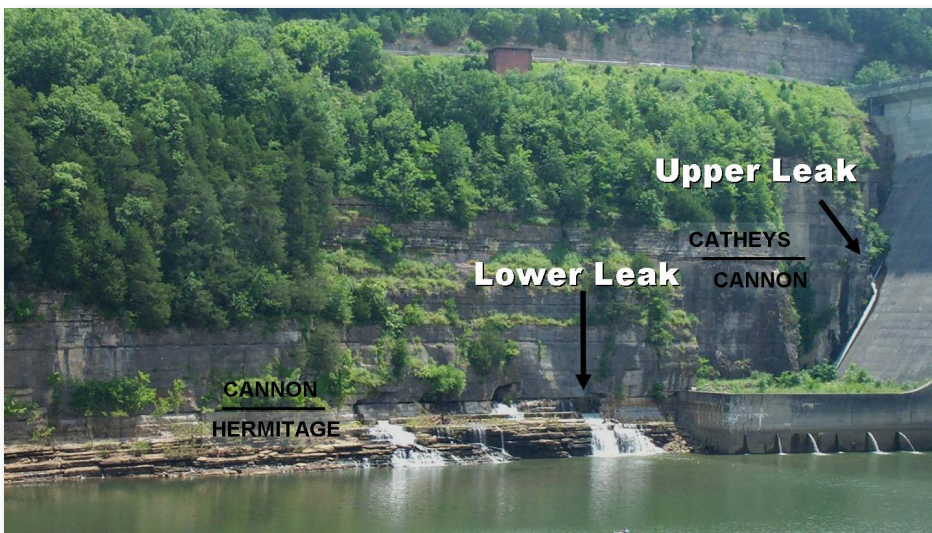
Seepage has been visible in the right bluff for many years. The upper leak began within 2 years of impoundment in the mid 1950's; the lower leak began 17 years after impoundment. These features represent a water loss problem and do not endanger the stability of the dam. We plan to address these features to control them while they are manageable.

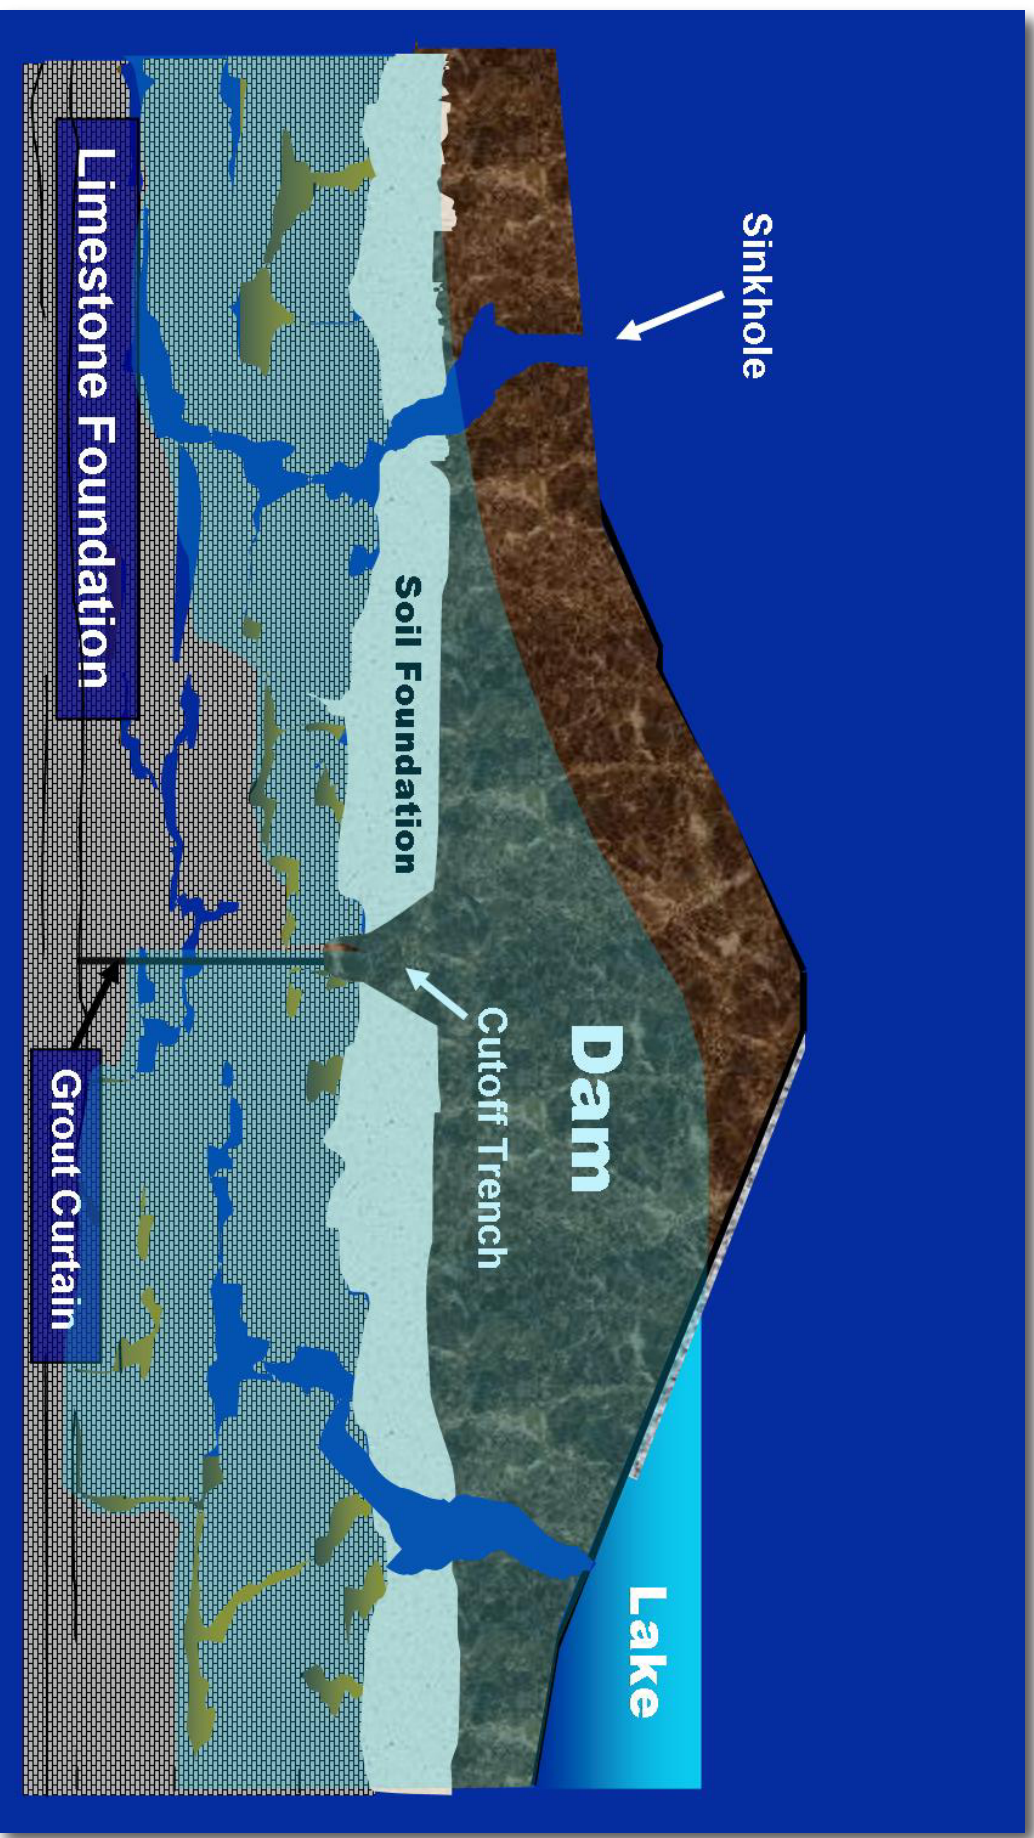
This illustrates a simplified cross-section of the earthen portion of the dam and the foundation. It further illustrates the danger of an inadequate foundation in karst geology. The brown area represents the large compacted clay embankment at Center Hill. It is well constructed in 4 to 6-inch lifts and sits on soils that were left in place. Beneath the soil is the karst limestone with open and clay-filled, sand or silt-filled cracks and joints called features. Lake water normally moves slowly through and under the earthen part of the dam. As water moves normally through the foundation, it begins to remove the materials from these features, allowing more water to move through faster and further, eroding the materials in the interconnected features. When one of these features opens to the surface, overlying material falls into the cavities and is washed downstream, causing a sinkhole at the surface. When the openings lead back to the lake, this is a very serious situation because there can be a direct connection from the reservoir to the downstream side, with water flowing under the dam unchecked.
